Cavity Wall Ties

Survey & Repair Summary

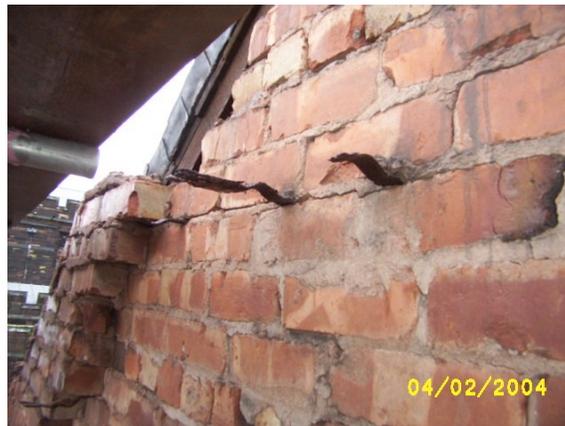
As ties corrode they expand and this *expansive corrosion can produce distinctive horizontal cracking* within the bed joints (usually, though not exclusively, outer leaf).

Such problems are normally restricted to the thicker metal and "fishtail" ties.

Corroded thick metal ties where outer leaf has been dismantled

- Complete tie replacement is recommended where the ties exhibit evidence of extensive corrosion and definitely where rusting is visible.
- For most walls the recommended fixing density is 2.5 ties/m² with additional ties at 300mm vertical centres at sides of openings and up verges.
- Where the existing ties are thin metal or wire butterfly type which have not caused any cracking, it is generally acceptable for them to remain in place.
- Where expansive corrosion of ties is causing cracking in the outer leaf these ties should be removed or structurally isolated from the outer leaf. *This can only be completed after the installation of remedial ties and is usually the more disruptive and expensive element.*
- If the ties are in good condition but low in density then it may be necessary to install supplementary ties e.g. at sides of openings.
